# YOUR Inspection Report

123 Sample St.  
Winnipeg, MB

RE: Report No. 1366, v.39  
123 Sample St.  
Winnipeg, MB

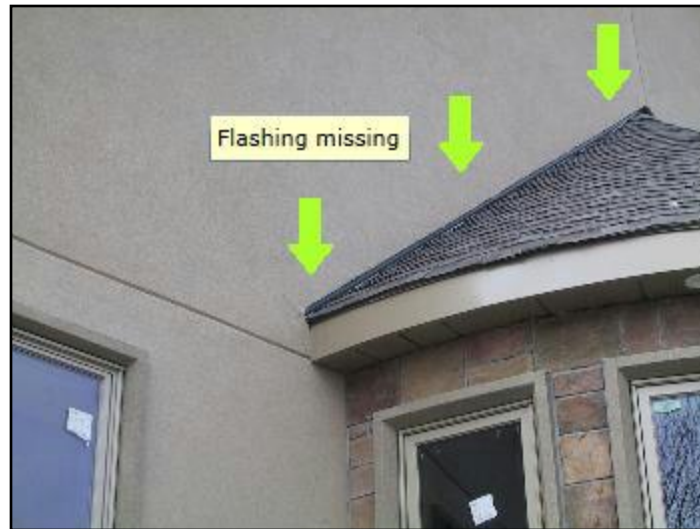
2. **Condition:** • [No kickout flashing](#)

**Implication(s):** Chance of water damage to contents, finishes and/or structure

1. No kickout flashing at roof/sidewall junction

**Task:** Improve

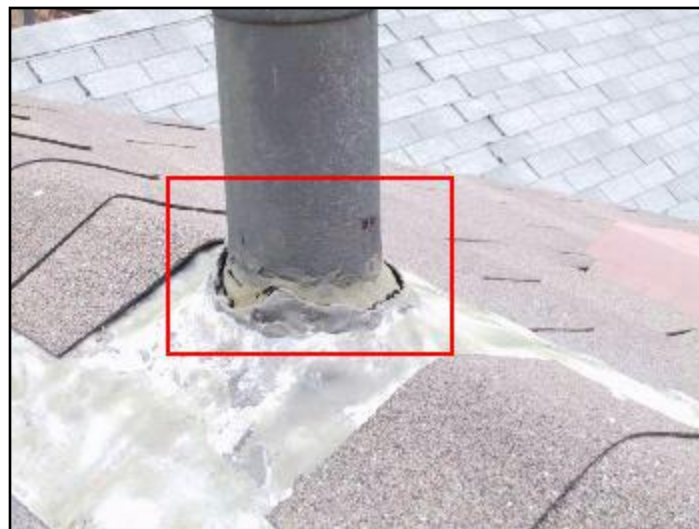
3. Condition: • [Leak](#)

**Implication(s):** Chance of water damage to contents, finishes and/or structure

2. Leak

**Task:** Repair, immediate

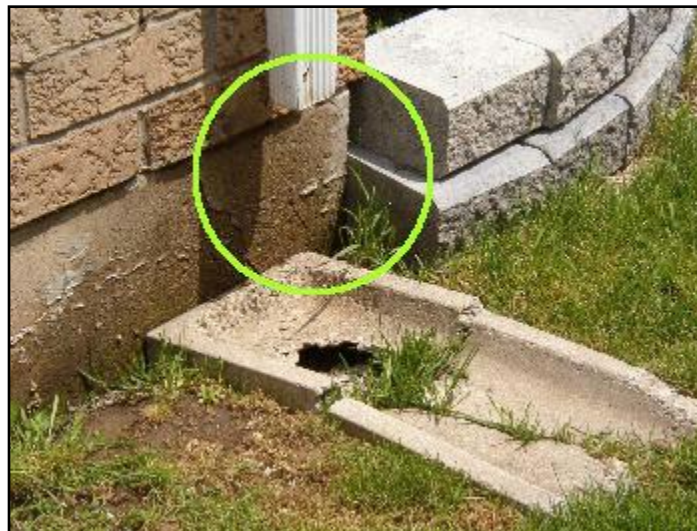
**4. Condition:** • [Downspouts end too close to building](#)

**Implication(s):** Chance of water damage to contents, finishes and/or structure

3. Downspout ends too close to building

The downspout should be extended to discharge at least 6 feet from the home. The splash block can be discarded.

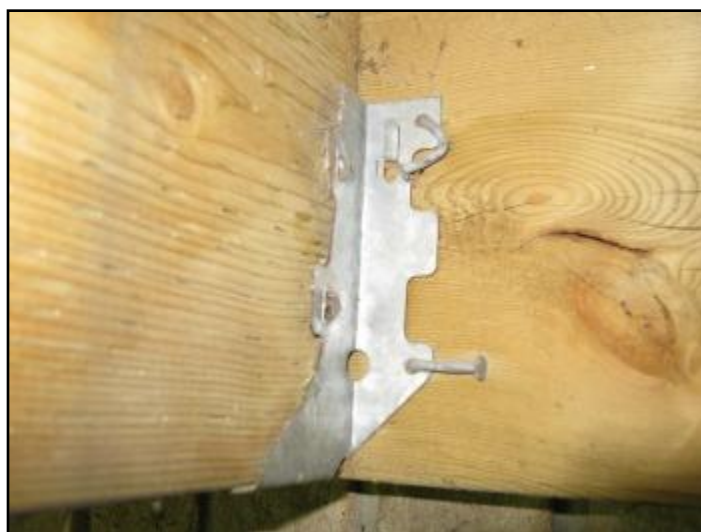
### **5. Condition:** • [Fastener problems](#)

Joist hangers for wood deck are not properly nailed.

**Implication(s):** Weakened structure | Chance of movement

4. Poor end bearing, joist hanger connections

**Task:** Improve

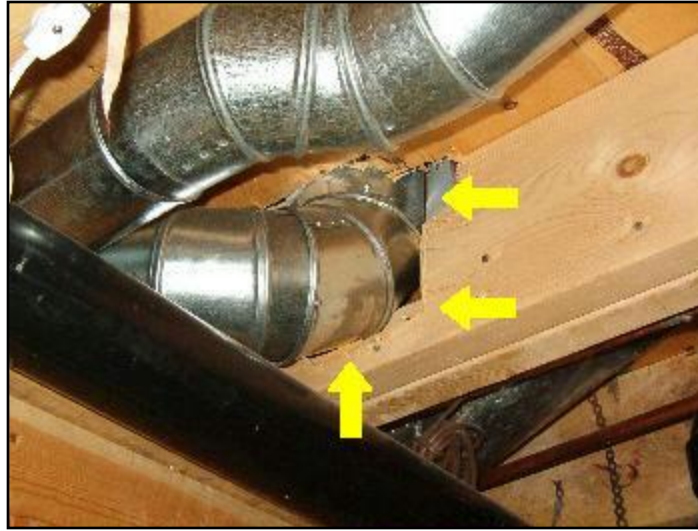
**6. Condition:** • [Notches or holes](#)

**Implication(s):** Weakened structure

5. Joists are notched and weakened

**Task:** Repair

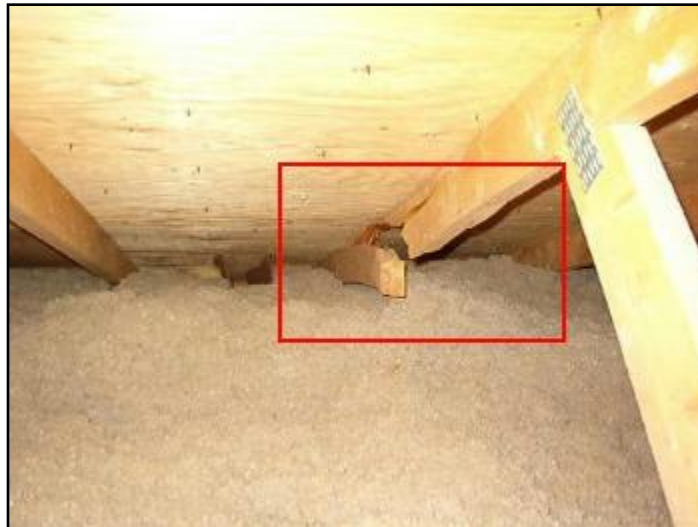
7. **Condition:** • Top chord of truss is broken

6. Top chord of truss is broken

**Task:** Replace

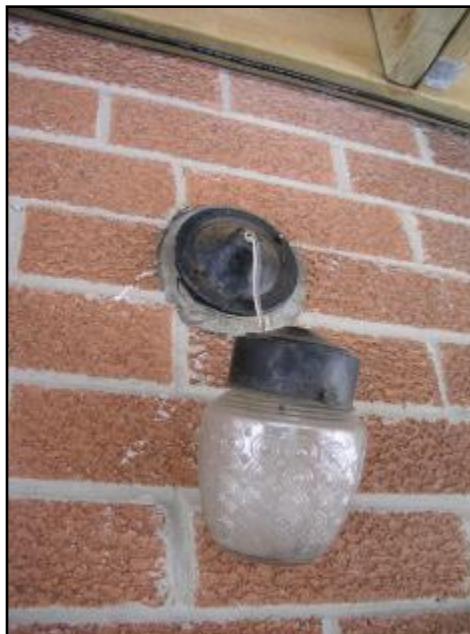
**12. Condition:** • [Loose](#)

*8. Light fixture is not well secured*

**Task:** Repair or replace

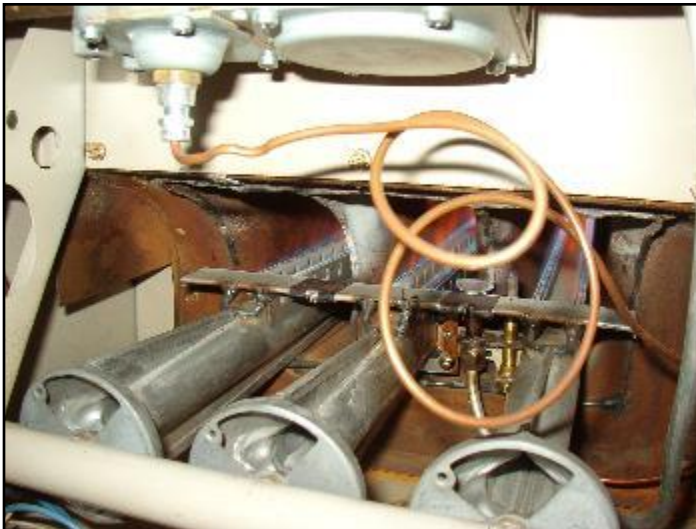
14. **Condition:** • [Draft hood spillage or backdraft](#)

A considerable amount of rust was noted on the front of the furnace.

This suggests a back-drafting problem, with combustion products entering the home.

9. Rust at bottom of heat exchanger

**Task:** Correct

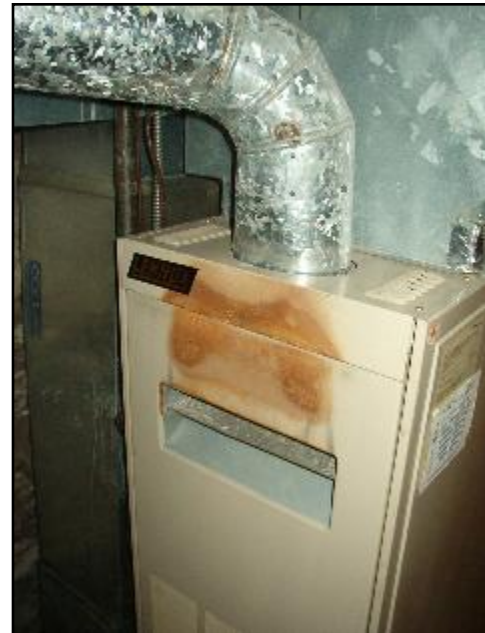
This is a safety issue that should be addressed without delay.

10. Evidence of furnace backdrafting

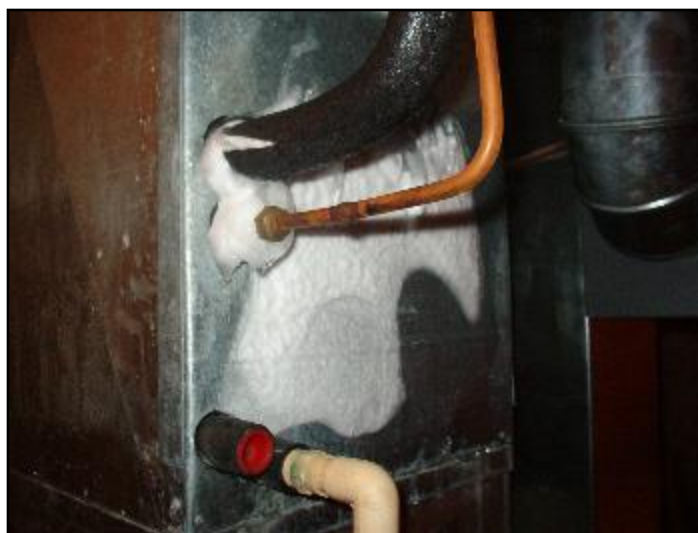
**15. Condition:** • [Frost](#)

**Implication(s):** Increased cooling costs | Reduced comfort

11. Frost visible on ductwork at AC coil

**Task:** Repair

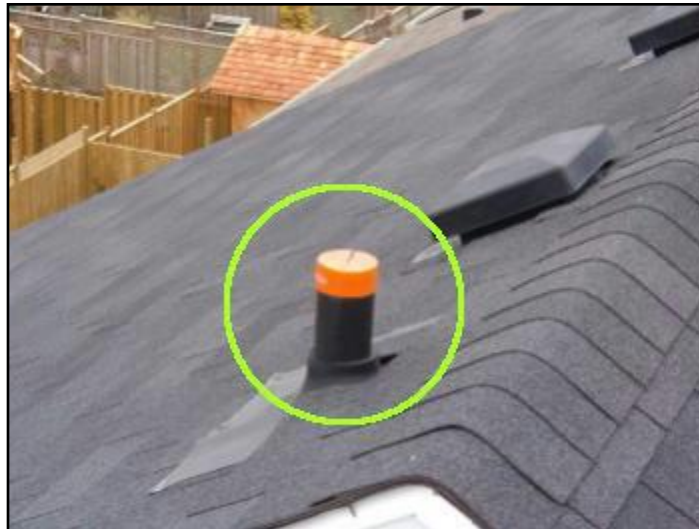
**19. Condition:** • [Vent termination problems](#)

**Implication(s):** Reduced operability | Sewer gases entering the building

15. Plumbing stack is capped

**Task:** Remove cap

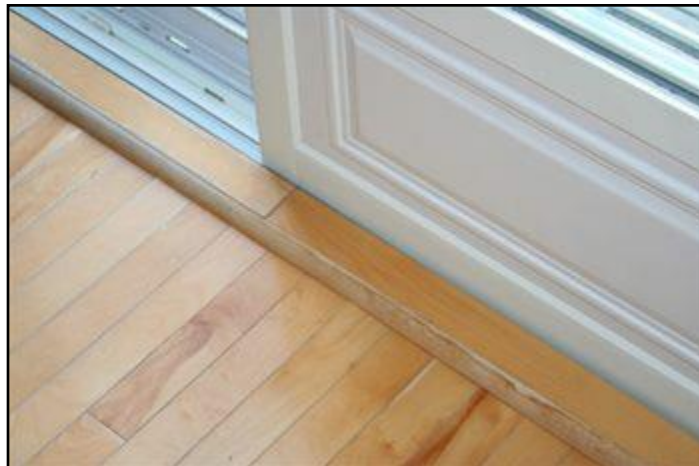
**20. Condition:** • [Stained](#)

**Implication(s):** Cosmetic defects

16. Stained

**Task:** Repair

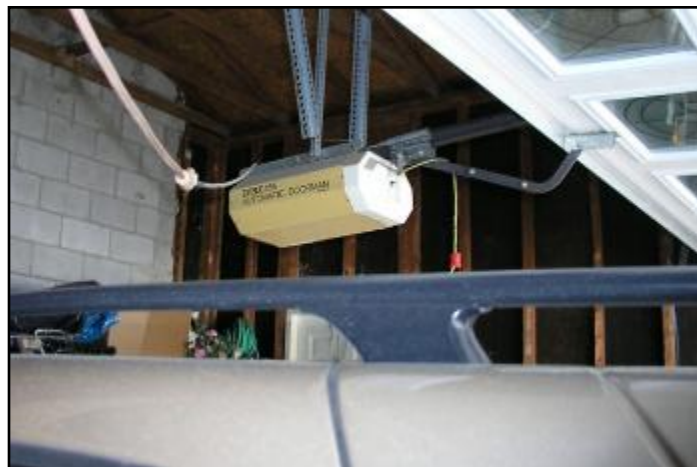
**21. Condition:** • [Extension cord for opener](#)

**Implication(s):** Electric shock

17. Extension cord for west garage door opener

**Task:** Replace with permanent wiring
