# YOUR Inspection Report

123 Sample St.  
Winnipeg, MB

RE: Report No. 1366, v.39  
123 Sample St.  
Winnipeg, MB

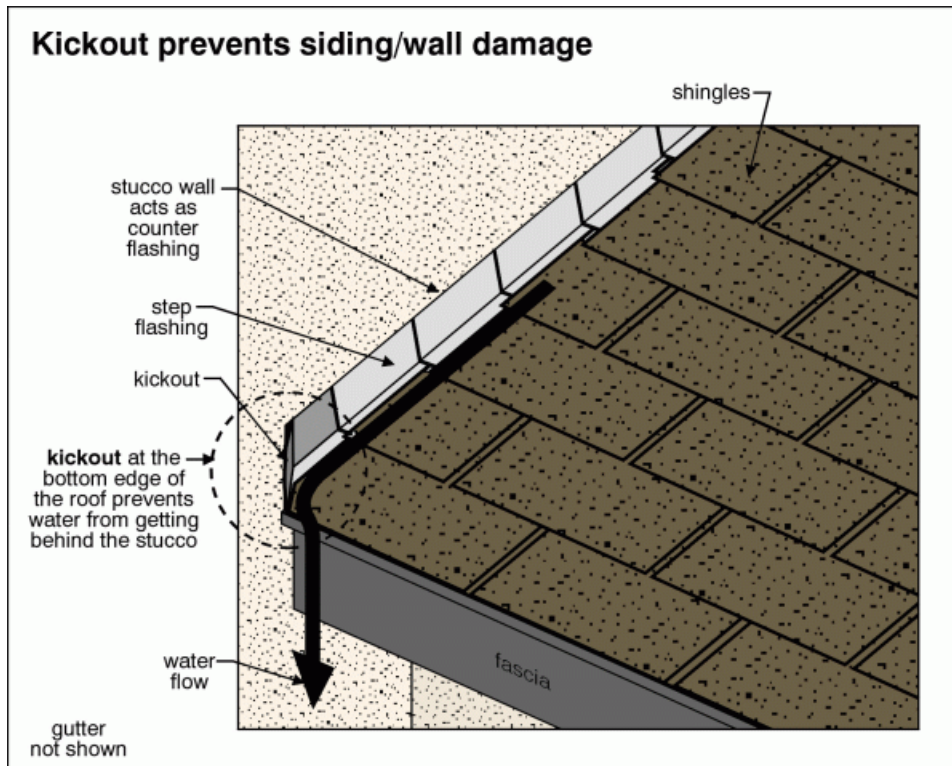
2. **Condition:** • [No kickout flashing](#)

**Implication(s):** Chance of water damage to contents, finishes and/or structure

**Task:** Improve

**Time:** Less than 1 year
